RE: City Auditorium – Building Evaluation and Master Plan

CJMW Architecture is pleased to submit this building evaluation and master plan to the City of Danville.

Existing Conditions:

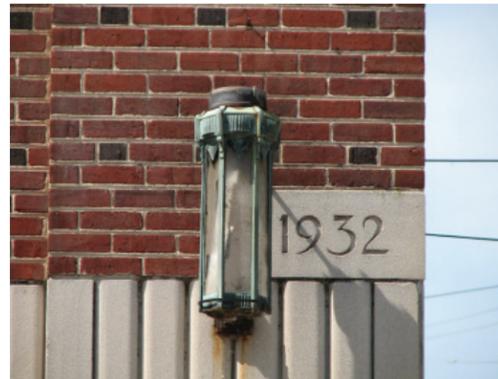
Original exterior light fixtures remain in place; these should be cleaned and maintained in good repair (Photo 1). Within the former elevator shaft, milk glass globes with original gold stenciling are stored (Photo 11). The globes are in two different dimensions – the larger likely relates to the auditorium globes. These globes should be documented and archived. Any future renovation should restore and reuse these original artifacts. One local company that does this type of work is Jefferson/Lightsmith (ltsmith.com; (434) 528-5809).

1: Exterior light fixture

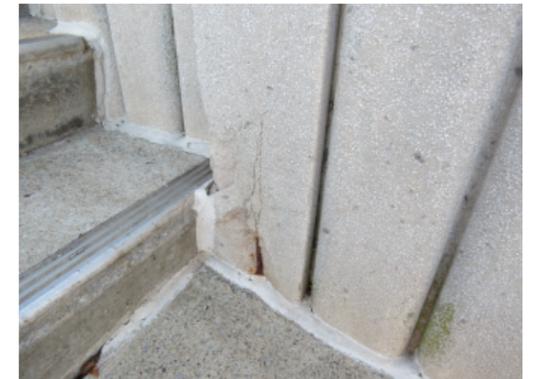
Exterior materials such as brick and stone masonry shall be cleaned by the gentlest means possible. High pressure water and metal bristle brushes can irreparably damage the detailing. Ice melt chemicals against the base of the building cause water damage to the joints and corrode the steel reinforcing bars (Photo 3). The roof flashing is allowing water to enter the interior and the parapet. Mortar joints have been improperly patched with mortar and/or sealant that does not match the existing mortar in color, texture or function (Photo 2).

3: Damage to existing exterior cladding from ice melt

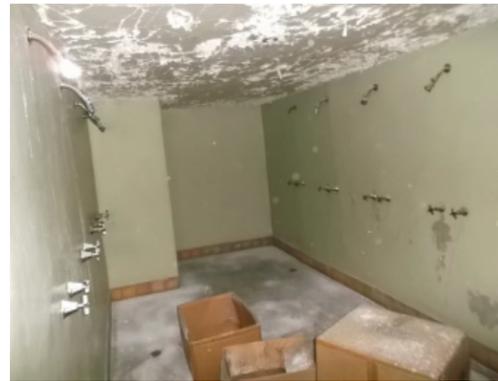
13: Former locker room showers

- The floor is not air conditioned. The perimeter rooms are heated by steam cast iron radiators. (Picture 29)
- Shower/toilets are not functional and are used for storage.

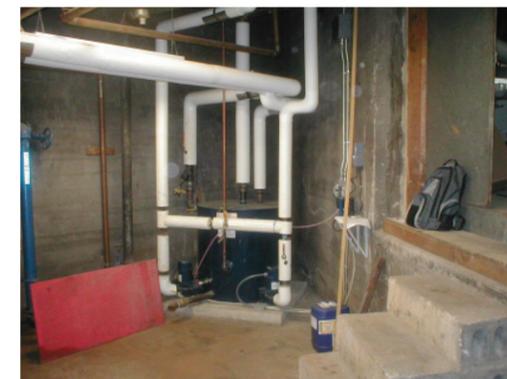
23: Condensate Receiver Tank

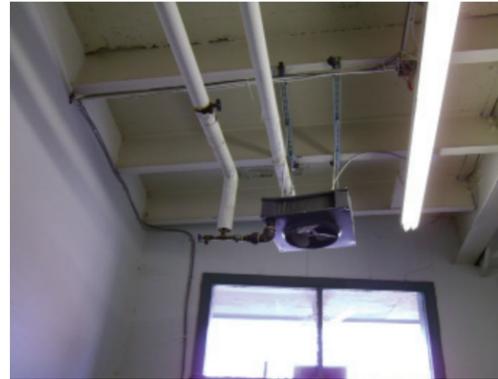
- There is a steam ceiling unit heater located at the entrance to the Print Plant. (Picture 25)
- The Print Plant is air conditioned and has a water mist humidification system. The air unit is located in the Wood Shop and the remote air cooled condensing unit is located/mounted on the wall in the drive-through below the Auditorium. (Picture 22, 27 and 41)

25: Steam ceiling unit heater in Print Shop

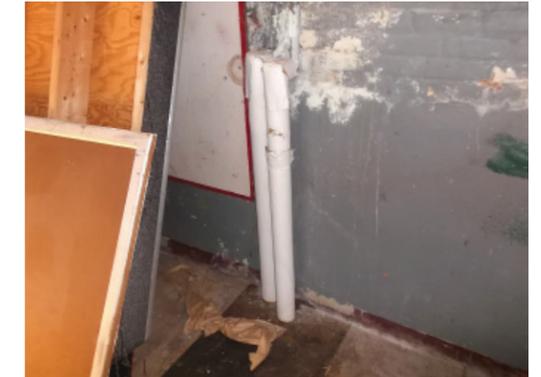
42: Water infiltration around piping
