City of Danville, Virginia

CITY-WIDE SPACE NEEDS ASSESSMENT

October 2016

Prepared by:
Solutions for Local Government, Inc.

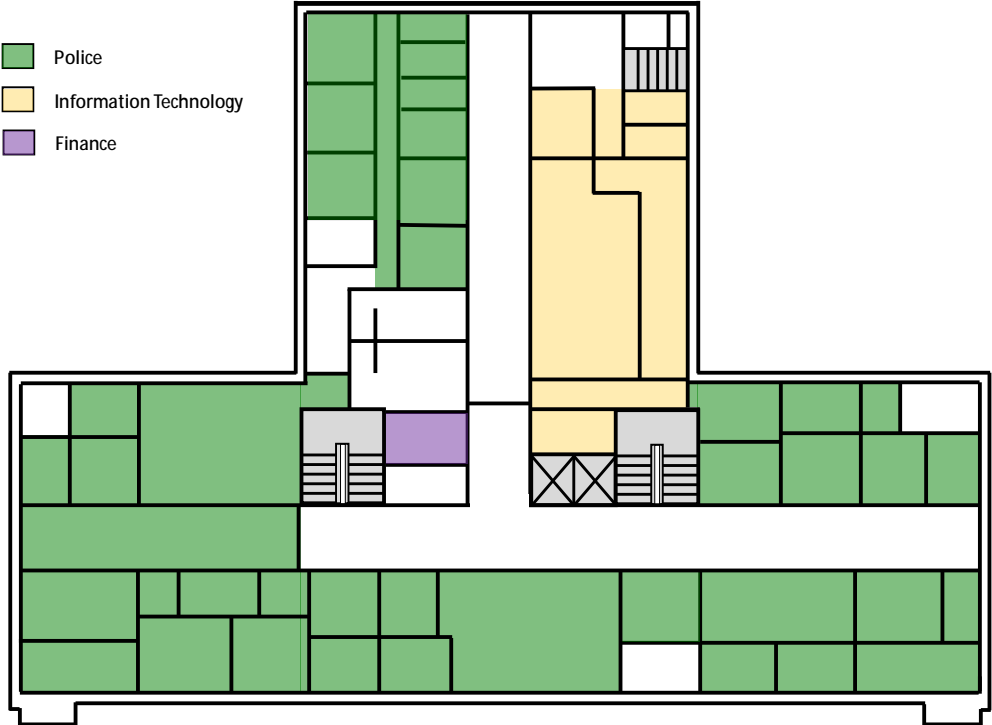
FIRST FLOOR-Existing

While various colors are used to differentiate existing or proposed occupant space(s), white areas represent common, open corridors, restrooms, and electrical and mechanical equipment spaces.

The pages that follow offer diagrams of the basement and first-fourth floors of City hall. Each illustrate either the current space as-is or that addressed in Recommendations 7-9.

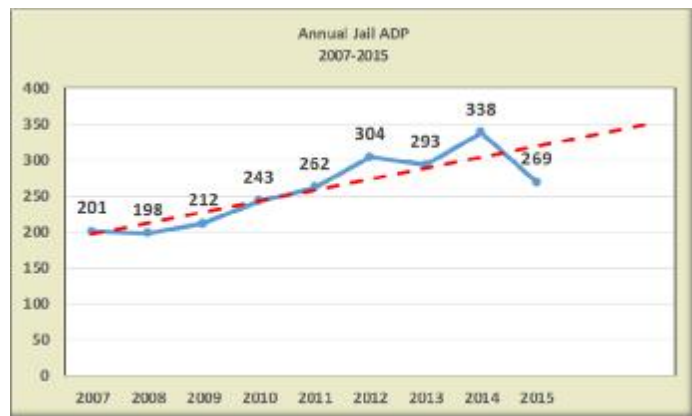
This graph illustrates the average daily inmate population (ADP) recorded for the Danville City Jail for the years 2007-2015. Note again, that the established capacity of Jail space available in Danville is 213. The red dashed line is the linear trend line, based on the nine years of data shown, of the direction in which the inmate population is expected to go.

On paper, the case can be made that the Jail is in crisis. It is *not* a management problem; staff is doing what they can with what they have to work with. Judges have increased the frequency of certain types of hearings specifically to keep inmates moving through the system. Positive working relationships with surrounding counties and the City of Martinsville have provided the opportunity for the Sheriff to move inmates to those jurisdiction's facilities when jail beds were available. The Adult Detention Center is designated to hold a certain number of beds for jail inmates and at times has been able to hold more.
