RE: City Auditorium – Building Evaluation and Master Plan

CJMW Architecture is pleased to submit this building evaluation and master plan to the City of Danville.

Existing Conditions:

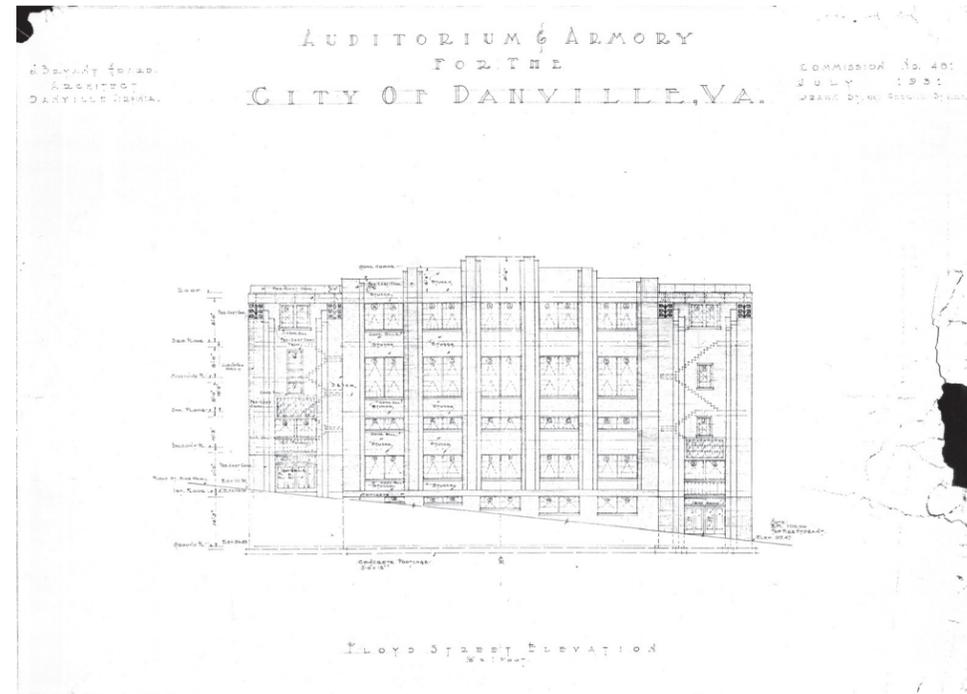
Cover Sheet of J. Bryant Heard (Danville, VA) Drawings for an Auditorium & Armory for the City of Danville Virginia, dated July 1931. This sheet features the six-story Floyd Street Elevation. The Art Deco vertical styling of the building is most apparent in the detailing of the brick facade piers, the stucco spandrels between windows, and the parapet, which have fluting, chevrons, and plant-like motifs. Even the plate glass openings feature Art Deco geometric rays.

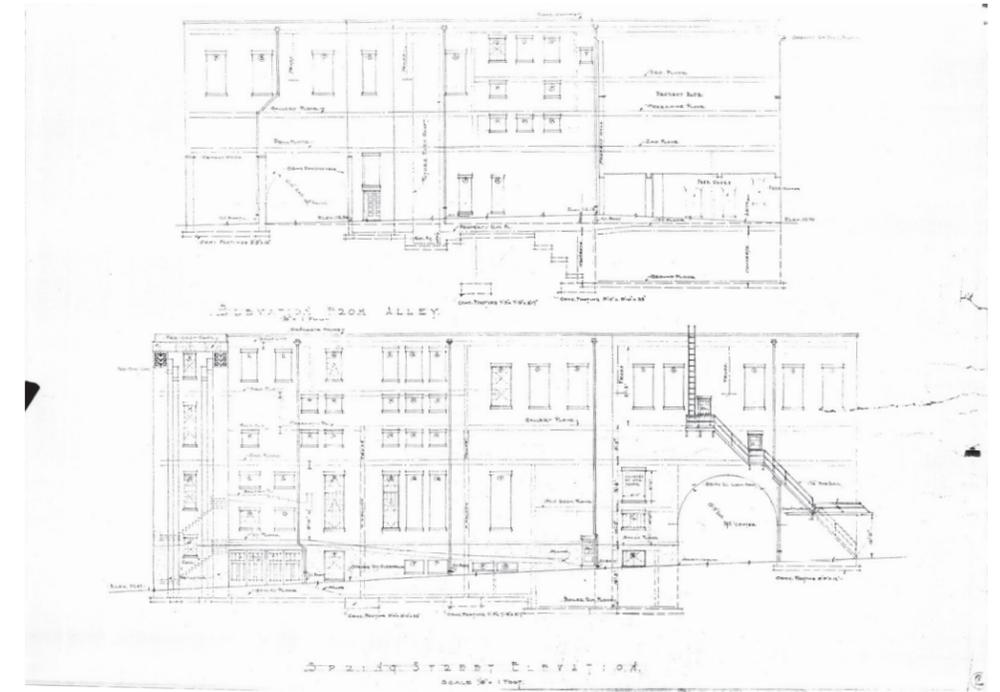
Sheet 2 features the Spring Street Elevation and the opposite side elevation. The Art Deco styling of the front elevation turns the corner one bay at the corner stair tower. The remainder of the Spring Street elevation continues the stretcherbond brick pattern. Industrial steel windows with concrete sills reveal the building's sectional quality. The Ground Floor is rendered as a stucco base along this elevation.

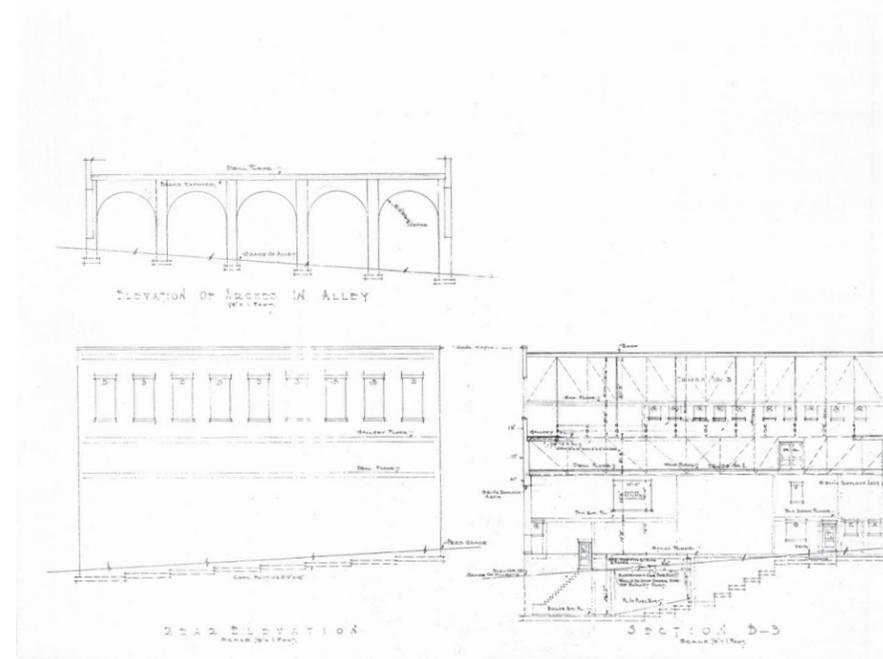
Sheet 3 picks up the remaining rear elevation as well as the arch elevation in the covered alley. A transverse section reveals the large No. 1 and No. 3 trusses that bridge the auditorium and gymnasium, as well as the suspended walking track or "Spectators Gallery" in the gymnasium area. The drawings call for "8 ring rowlock arches" to span the alley to carry significant compressive stresses from the trusses above.

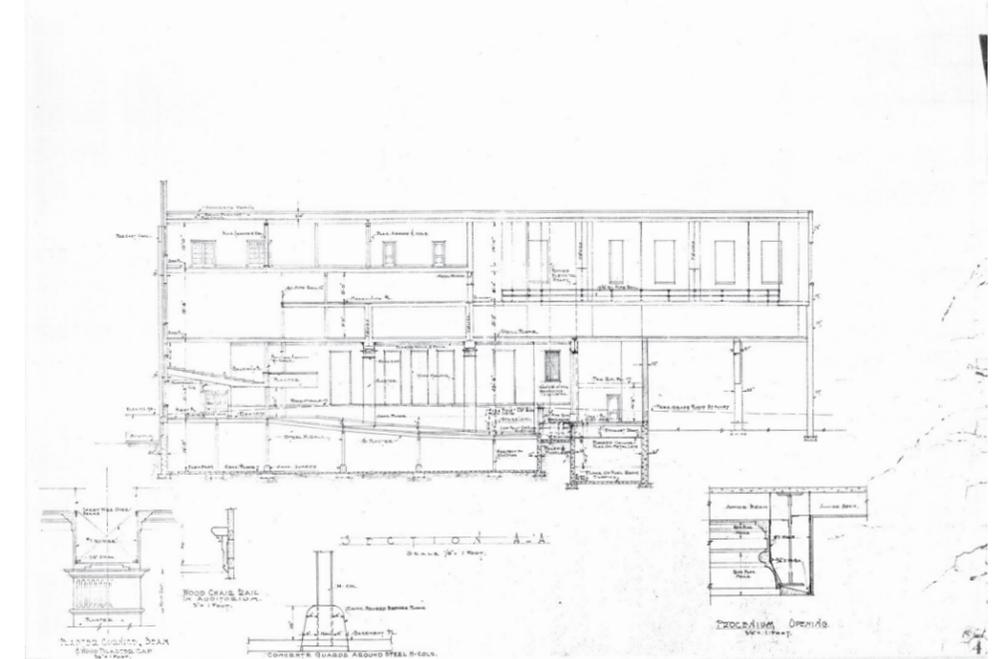
Sheet 4 shows a beautiful longitudinal section cut through the center of the auditorium and the proscenium arch. As drawn, the First Floor level corridor was open to the sloped auditorium floor. The Club Rooms on the Second Floor were double-height spaces with ceiling heights of 18'-6". The gymnasium soars to a 30'-0" tall ceiling.

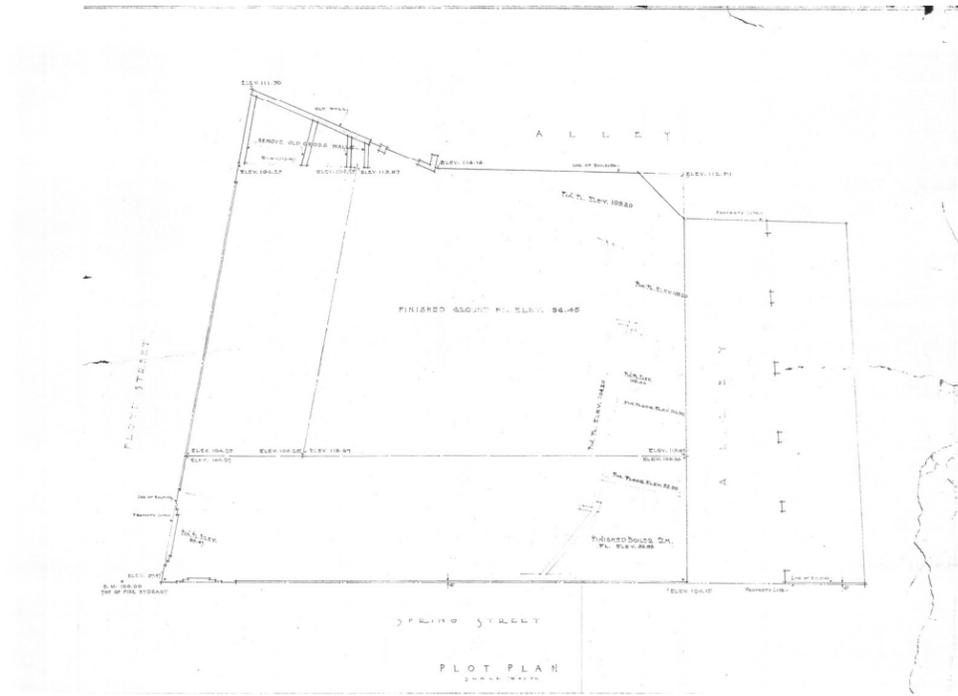
The Plot Plan shows the building tucked into the earth at the corner of Floyd and Spring Streets, completely filling the parcel. An alley is shown cutting through the building, behind the stage, up to a second alley parallel to Spring Street. The plan also shows the remnants of an existing wall and cross bracing.

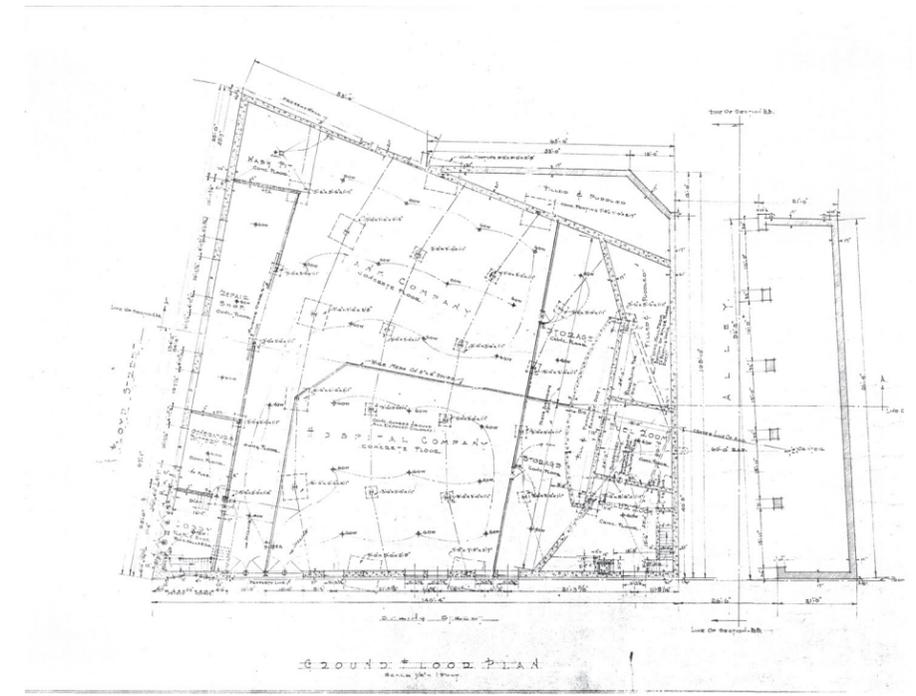
The Ground Floor had spaces designed for the heavy equipment assigned to the local Tank Company and the Hospital Company. A Generator/Battery Room was located along Floyd Street, along with a repair shop and wash pit. A public stair tower and Lobby at the corner of Floyd & Spring Streets provide access to all floors.

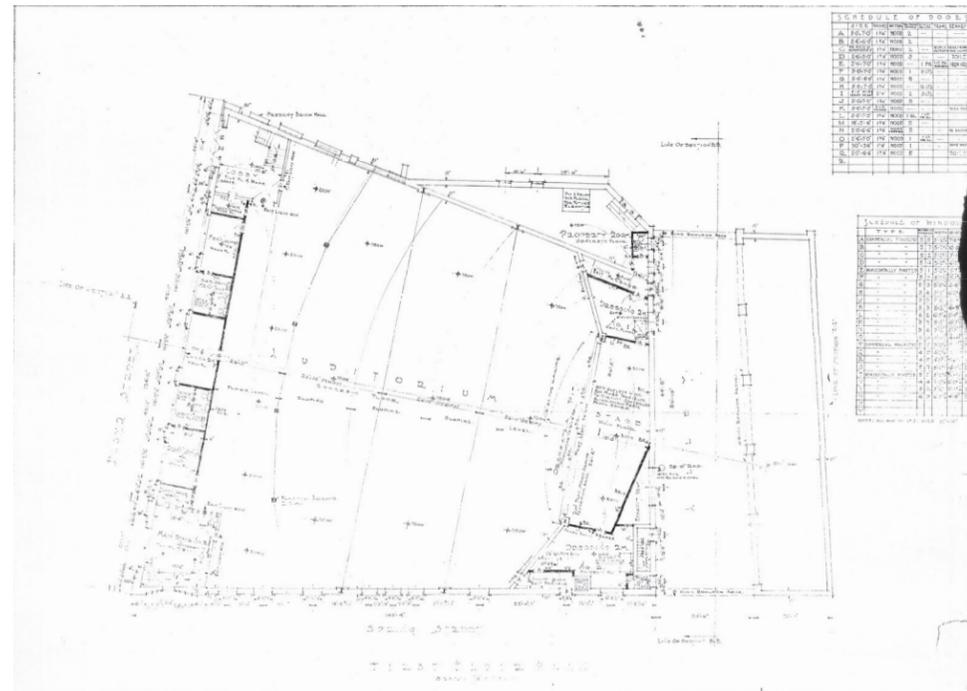
The First Floor contained the Municipal Auditorium space with a proscenium stage and small orchestra pit drawn. Originally the level corridor was open to the sloped auditorium floor. Later, a wall was built in line with the face of the balcony and four small sound/light locks provided. The Check Room along Floyd Street was converted to a street access stair. Men's and women's toilets are in place.

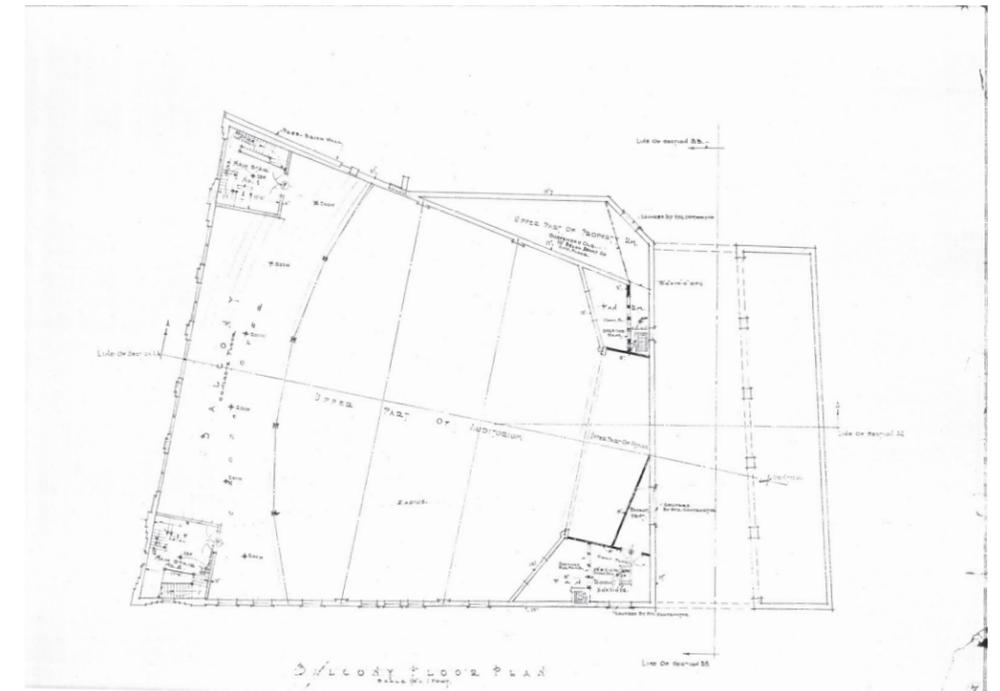
The Balcony Level provides stair access on each side to the balcony. No lobby or patron amenities are located at this level. The balcony contains concrete tiers and crossover aisle. Natural light from Floyd Street and Spring Street sides fill the auditorium and balcony space.

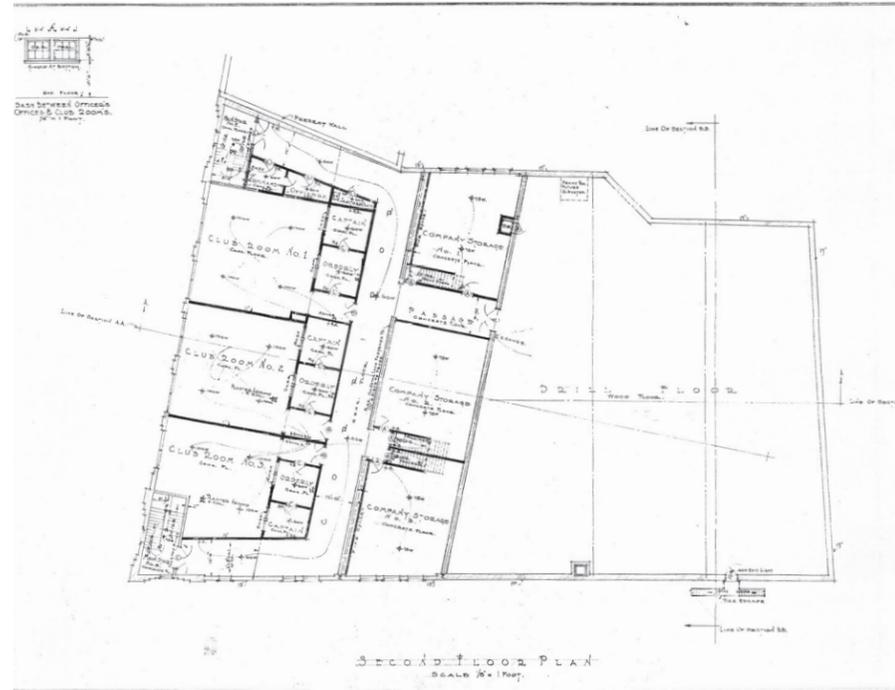
The Second Floor contained three Club Rooms (with 18'-0" tall ceilings) along with office space for the commanding officer and an orderly. On the opposite side of the hallway were three Company Storage Rooms. Each storage room provided private stair access to the locker rooms above. The Second Floor also provides the primary access to the Drill Floor gymnasium.

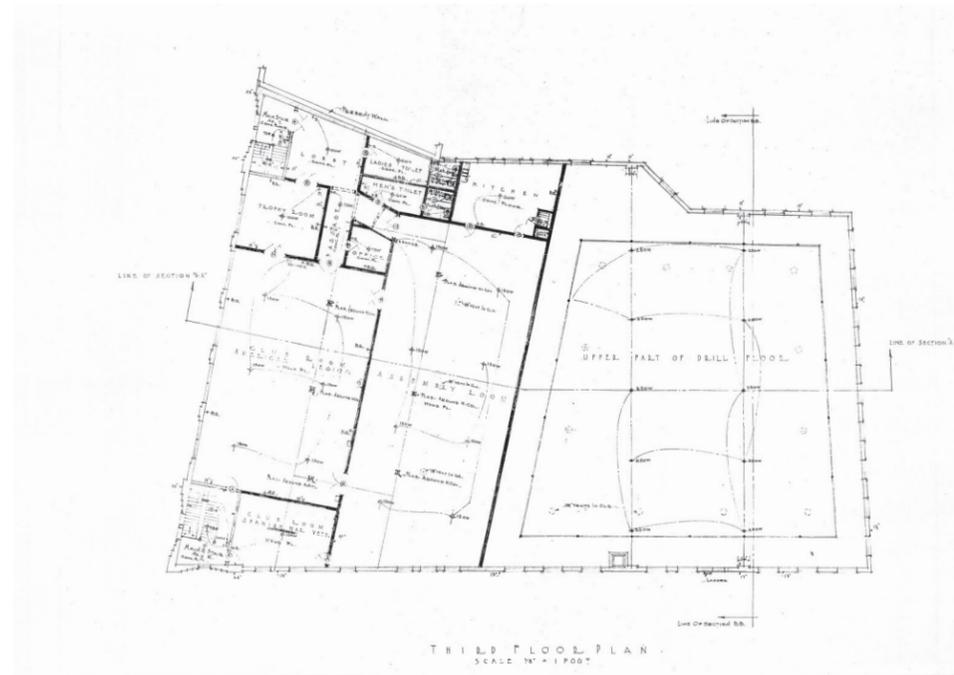
The Third Floor contained the American Legion Club Room, the Spanish War Vets Club Room, and a large Assembly Room. Men's and women's toilets and a kitchen (with dumbwaiter to the Drill / gymnasium floor) served these social rooms. A small stage with wings was later constructed at one end of the Assembly Room.

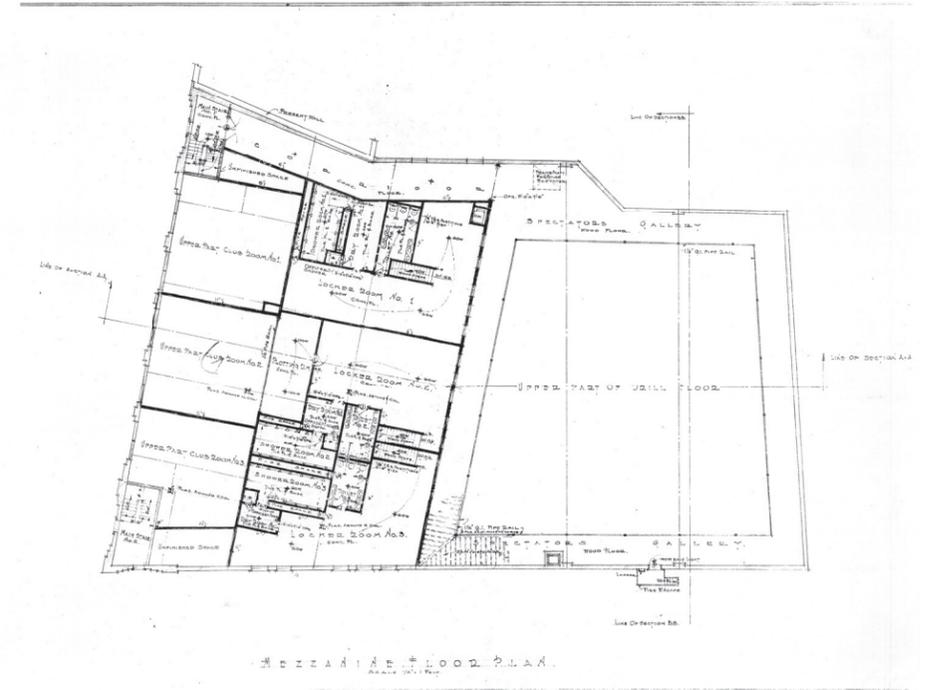
The Mezzanine Level contained the upper portion of the Club Rooms and the Company Locker Rooms. Each locker room had separate toilet/lavatory, dry and shower compartments as well as lounge space. Each locker room had windows overlooking the Drill Floor. Along one side lies the primary access to what the drawings term "Spectators' Gallery" which is currently used as a walking/running track around the gymnasium.

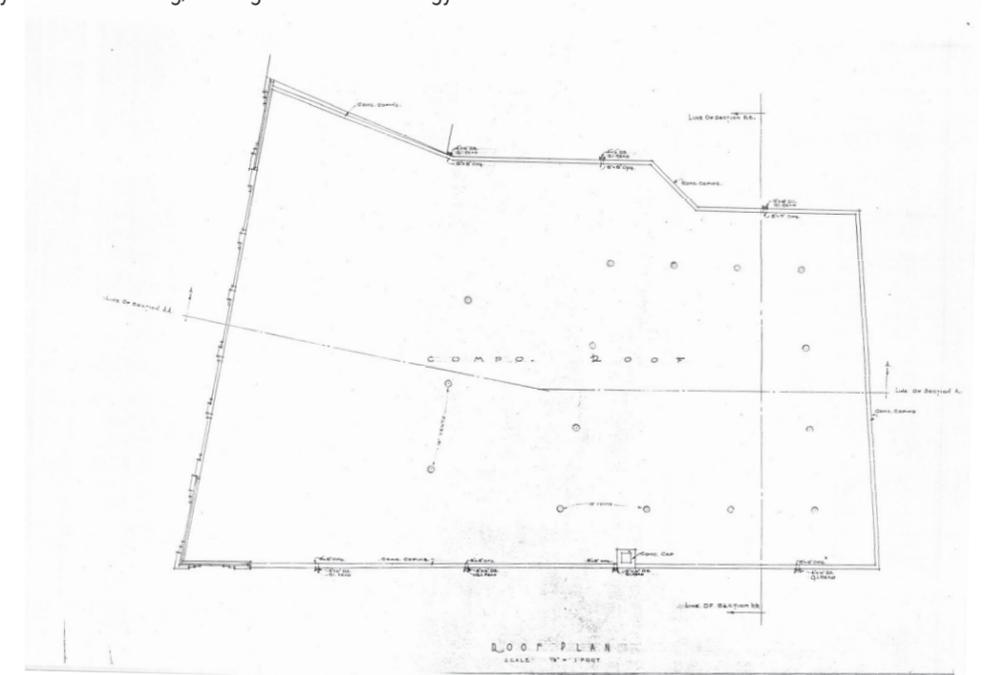
The Roof Plan shows a low-slope "composition roof" sloping to through-wall scuppers along the Spring Street and opposite side of the building.

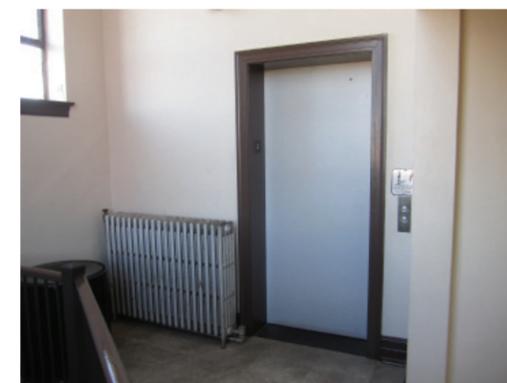
11: Existing elevator

One elevator serves the building. Multiple minor handicapped accessibility challenges are present throughout the building at thresholds, clearances, operation (grasping, turning), and wheelchair usage.

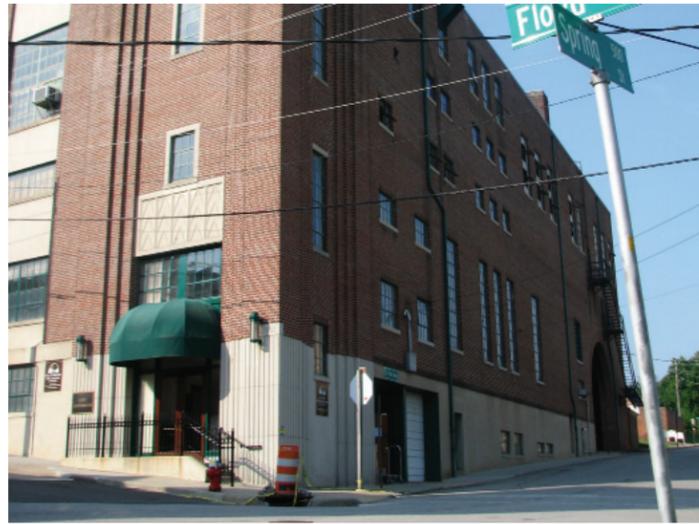
1: Public accessible entrance at Floyd & Spring Streets

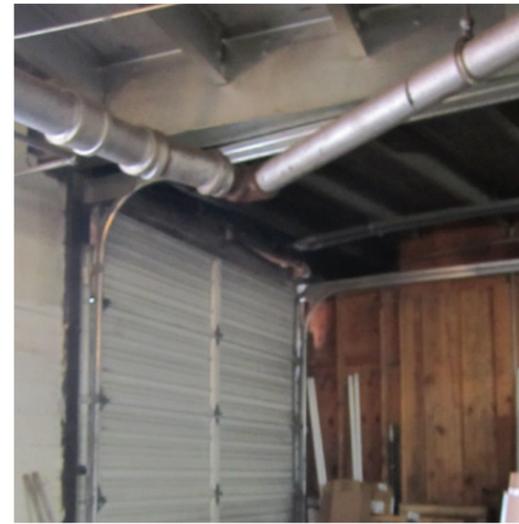
2: Garage door exit to Spring Street from Carpentry Shop

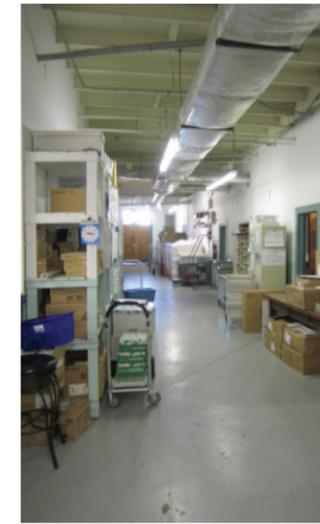
3: Exit to Spring Street from Print Shop

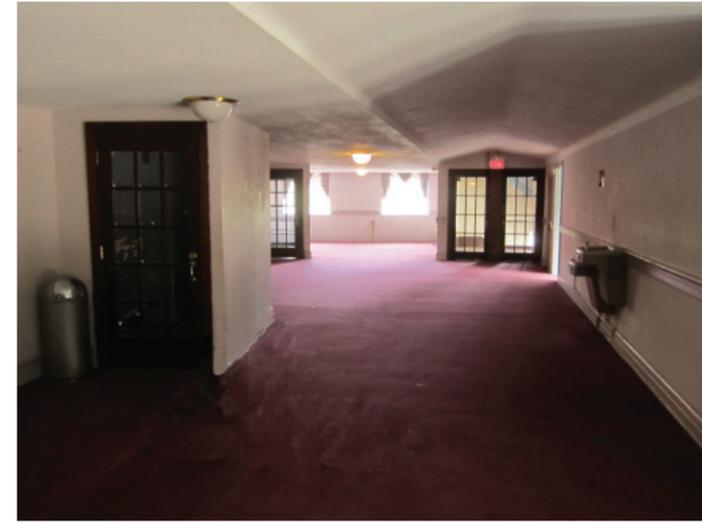
3: View within Auditorium lobby, and sloped underside of balcony above

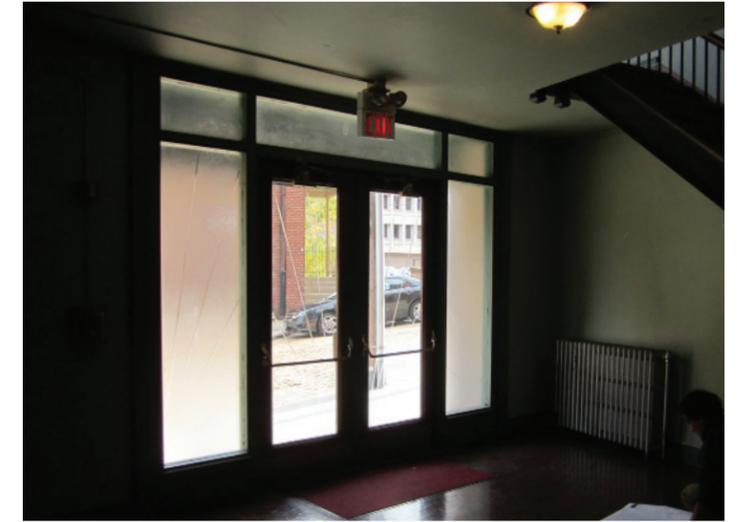
4: Stair 2 to Floyd Street - note Art Deco rays in plate glass

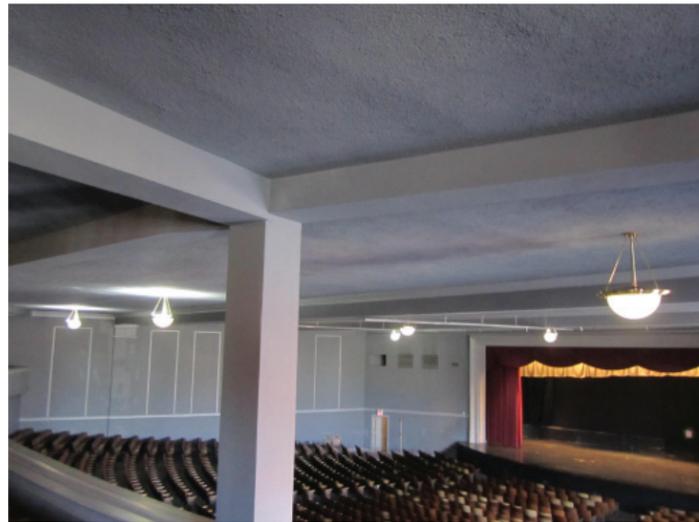
4: Structural framing at Balcony

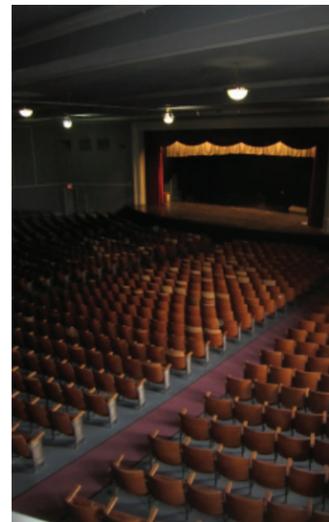
Seat runs vary between 85 feet and 120 feet long. Additionally the current row-to-row seat spacing is 30 inches, which is very narrow and the number of seats in each row exceed current egress limits. Deficiency.

6: Auditorium seating layout

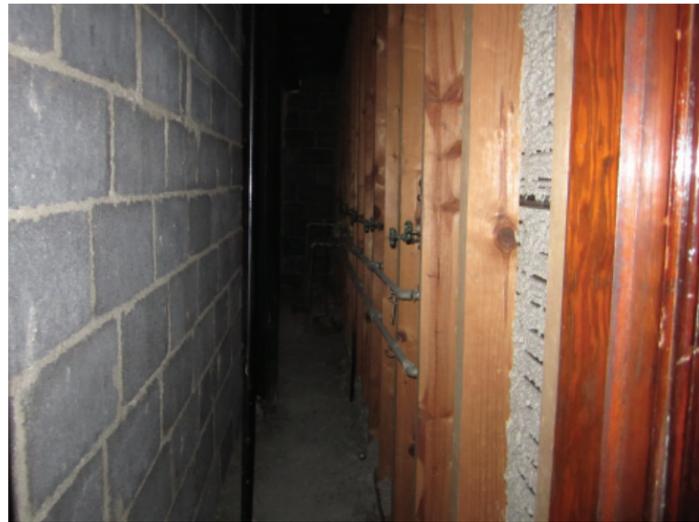
1: Plumbing chase at former showers

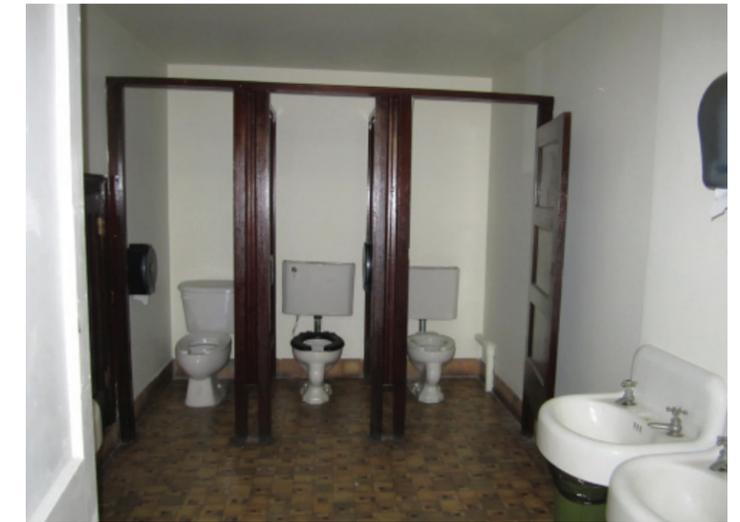
3: Former toilets with varnished partitions and original tile

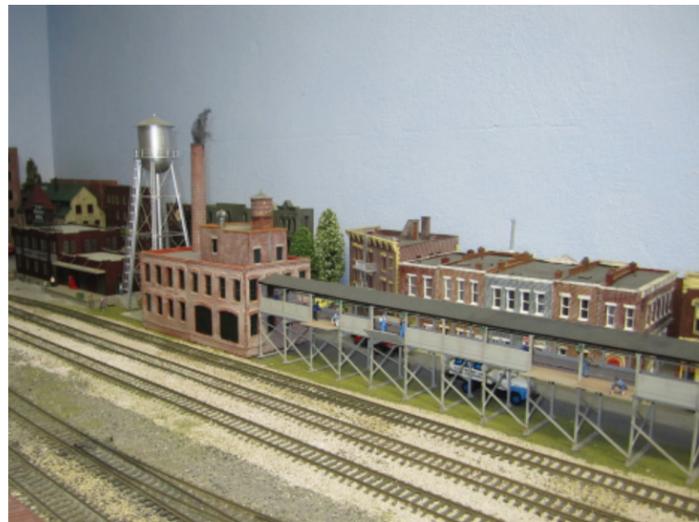
8: Detail of model railroad display

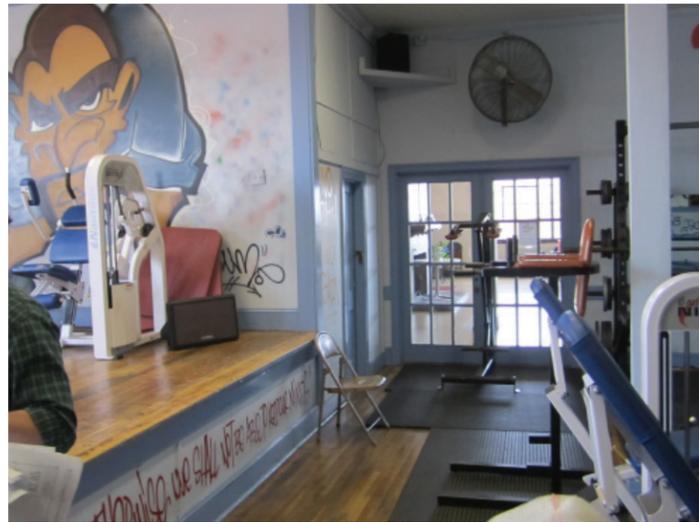
1: Small stage added in previous renovations. Original French door pair.

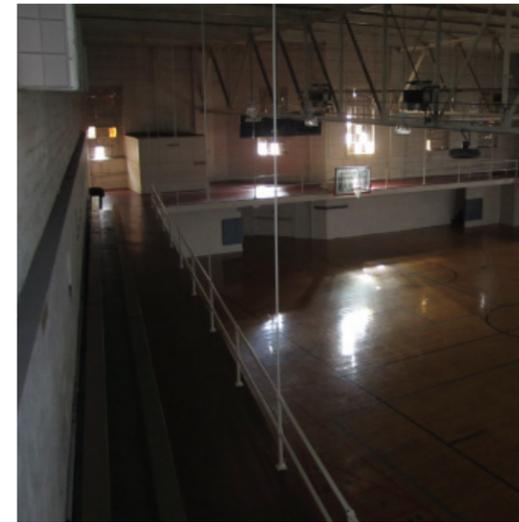
2: View down to the Spectators Gallery

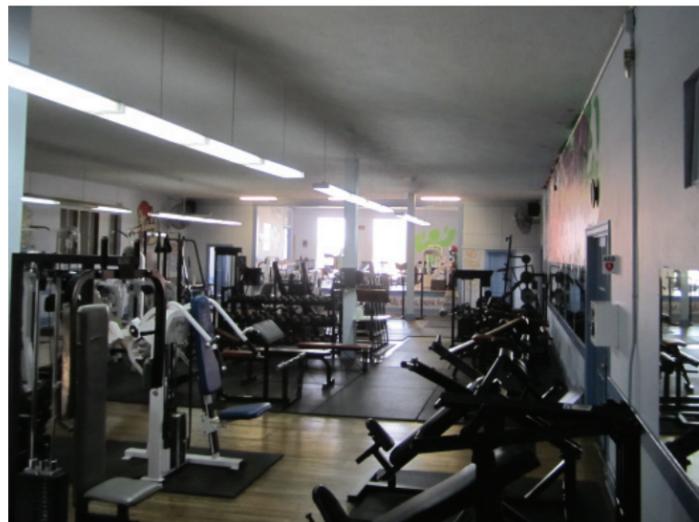
2 exits are required. Currently two exits are provided – one at Main Stair 2 and one using a stair to the fire escape to Spring Street. The previous elevator installation truncated the Main Stair 1 at the Second Floor. The path to the second exit/fire escape is very tenuous and easily blocked as it passes through the Fitness Room and Stage. Deficiency.

5: View towards Second Exit in lefthand rear corner of space.

The primary recommendation for this floor is to insert a Stair 1 extension and providing a corridor to link the Main Stair Exits, and re-route the wheelchair access via the existing elevator.

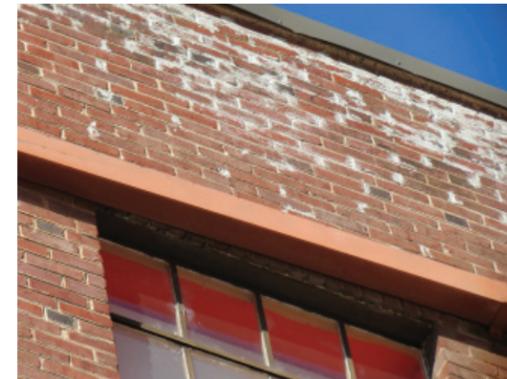
2: Mortar joints at roof parapet

Exterior materials such as brick and stone masonry shall be cleaned by the gentlest means possible. High pressure water and metal bristle brushes can irreparably damage the detailing. Ice melt chemicals against the base of the building cause water damage to the joints and corrode the steel reinforcing bars (Photo 3). The roof flashing is allowing water to enter the interior and the parapet. Mortar joints have been improperly patched with mortar and/or sealant that does not match the existing mortar in color, texture or function (Photo 2).

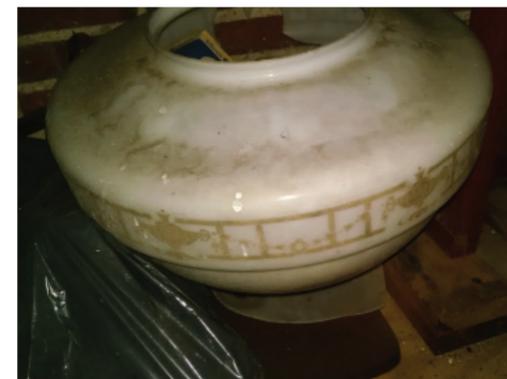
Original exterior light fixtures remain in place; these should be cleaned and maintained in good repair (Photo 1). Within the former elevator shaft, milk glass globes with original gold stenciling are stored (Photo 11). The globes are in two different dimensions – the larger likely relates to the auditorium globes. These globes should be documented and archived. Any future renovation should restore and reuse these original artifacts. One local company that does this type of work is Jefferson/Lightsmith (ltsmith.com; (434) 528-5809).

11: Historic light fixture glass globe

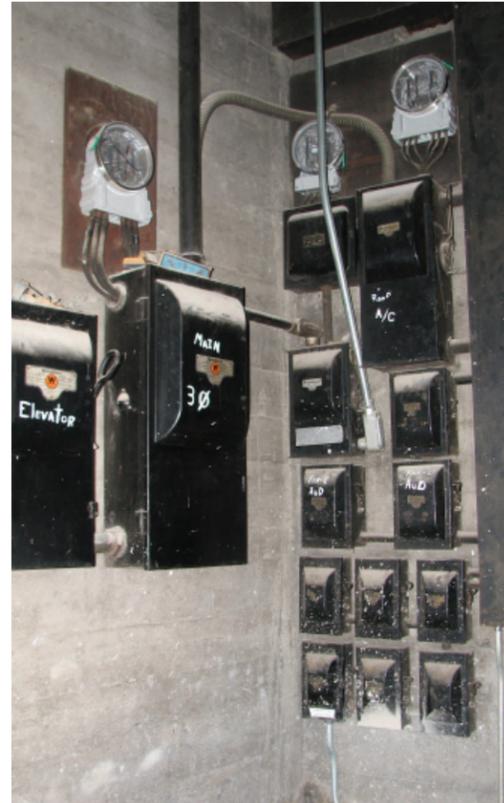
1: Electrical service

- The facility's existing electrical distribution system largely consists of, what is surmised to be, original (1930's vintage) wiring and very old distribution equipment (panelboards, disconnects, switches) that are long past their useful life. There are a number of locations that have "updated" load center circuit breaker panelboards, which look to be relatively new, but are "single-phase" 120 / 240 V(ac) devices. All "three-phase" equipment is fed from the old (original) electrical equipment.

Not being able to physically see the existing (original) wiring, it is surmised that all of it is well past its useful life. (Pictures 49, 50 and 51)

- The building does have a basic fire alarm system, but does not have an automatic actuation system or sprinkler system.
- With respect to possible (future) "phased" renovation efforts, KINCAID & ASSOCIATES, PC (K&A, PC) would initially recommend that the existing "over-head" building service be replaced with a new, under-ground, 208Y-120 V(ac) / 3 Ph / 60 Hz "Wye" arranged system. As a part of this replacement project, the service capacity should be increased to accommodate the higher power requirements for new Auditorium / Gymnasium HVAC equipment.

- Following the upgrade of the building service entrance, K&A, PC would propose that all of the older existing electrical distribution equipment be removed and replaced. Some of the existing equipment may not still be serving any loads.

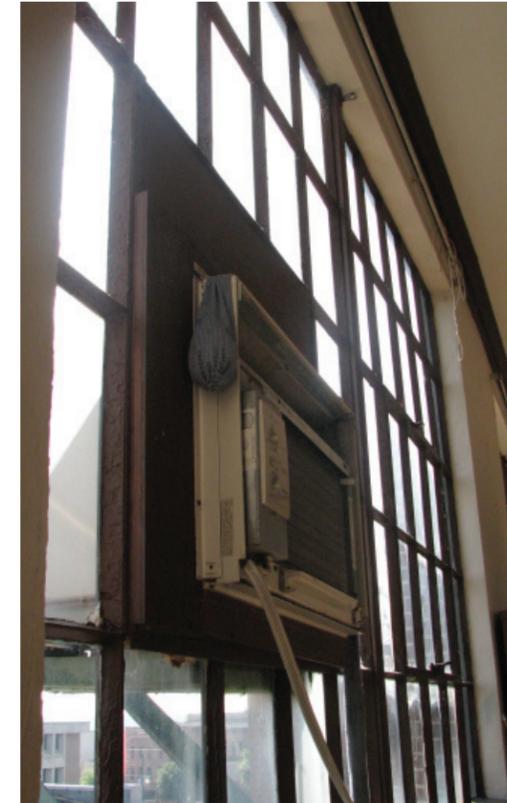
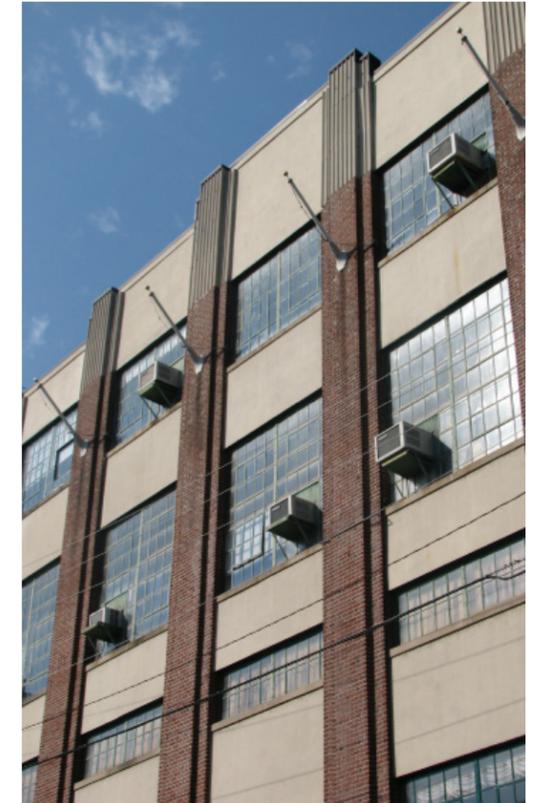
Window air conditioning units are in place along the west facing facades. A full building chiller system is recommended.

3: Typical window units on Floyd Street

4: Typical window units on Floyd Street

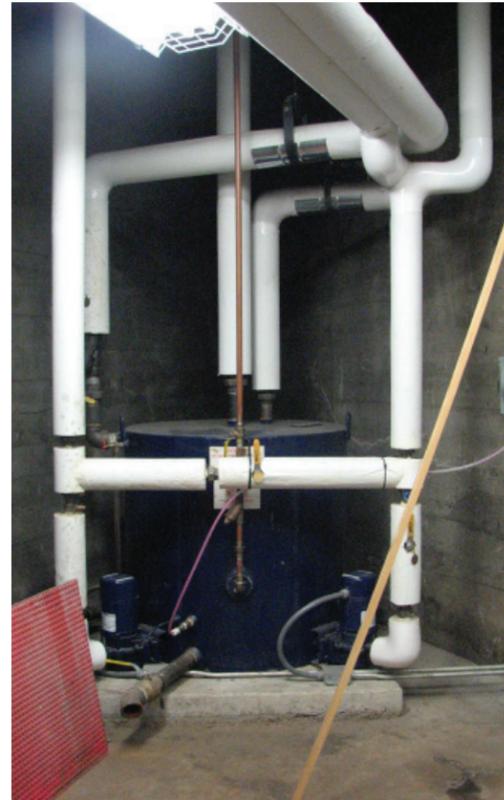
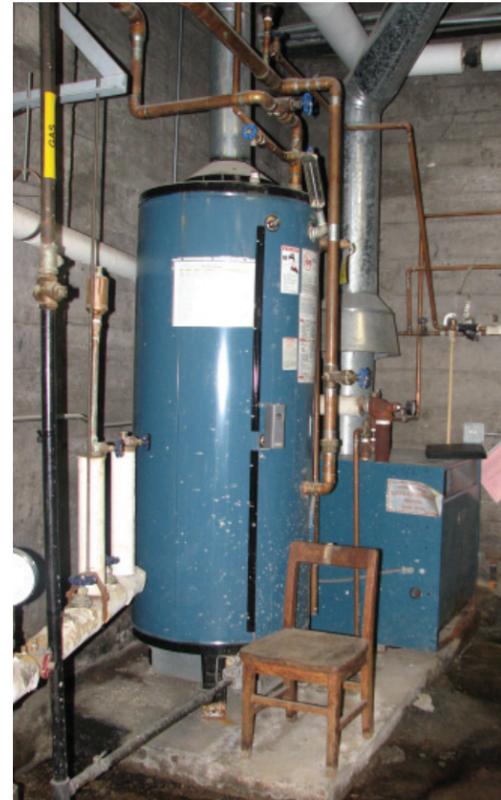
5: Boiler room equipment

6: Boiler room equipment

- Building steam heating boilers are located in the Boiler Room. The heating plant consists of two natural gas fired Columbia boilers that were installed within the last five years and appear to be in good condition. (Picture 21).

The current building heating system is low-pressure steam. Changing to a hot water heating system is recommended for this project. Relocating the boilers for a new system is possible, although relocating the exhaust flue would be challenging. The current exhaust flue originates at the Boiler Room and exhausts through all floors to the roof.

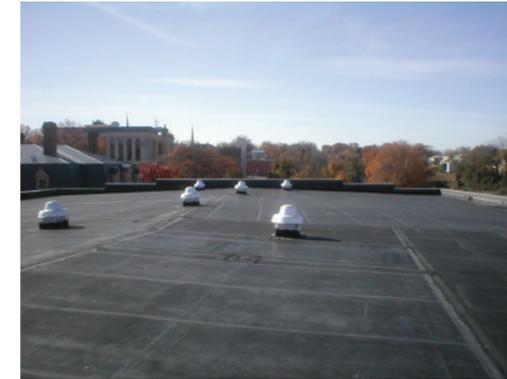
17: Roof top view

- Floyd Street offices are air conditioned by window air conditioning units and floor mounted self-contained spot coolers. Heating is provided by steam cast iron radiators.
- The Basketball Court is not air conditioned. It has rooftop exhaust fans for ventilation and steam unit heaters for heat. (Pictures 17 and 35)

- Basketball Court exhaust fans and a failed air cooled condensing unit for the Third Floor offices are located on the roof. (Pictures 17 and 20)

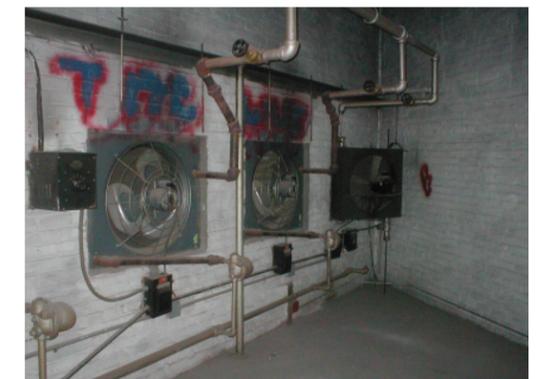
- The Auditorium and Stage area is not air conditioned and is heated by steam unit heaters located left and right of the stage. (Picture 24). Remaining spaces are also not air conditioned and heated with cast iron steam radiators.

24: Steam unit heaters for Auditorium (each side of Stage)

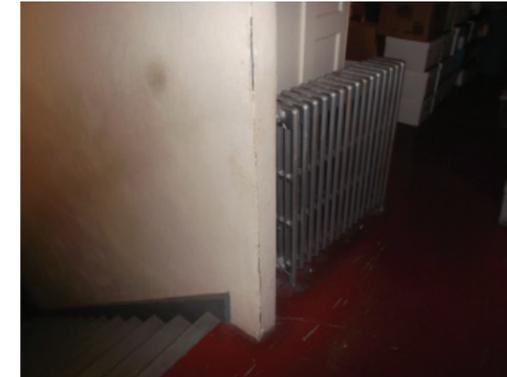
- The floor is not air conditioned. The perimeter rooms are heated by steam cast iron radiators. (Picture 29)
- Shower/toilets are not functional and are used for storage.

30: Steam radiators leading to Spectators Gallery

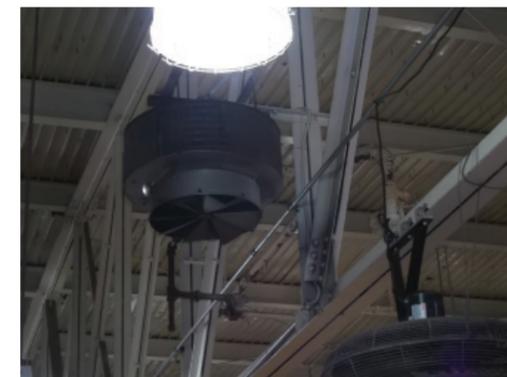
36: Exposed conduit and piping

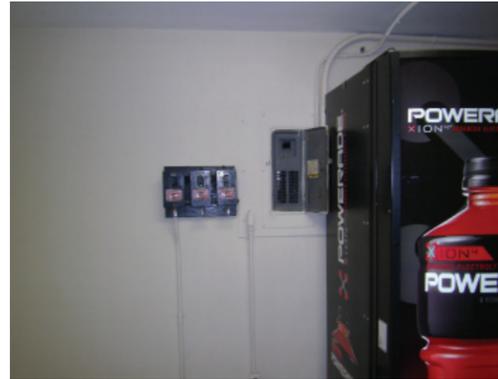
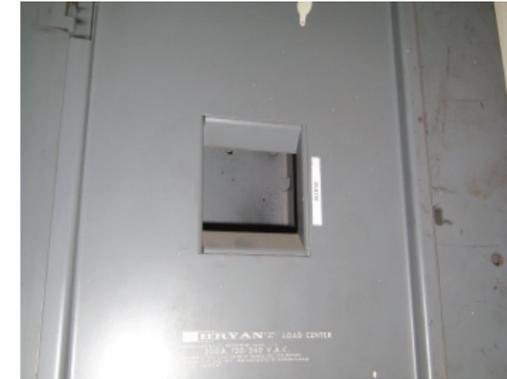
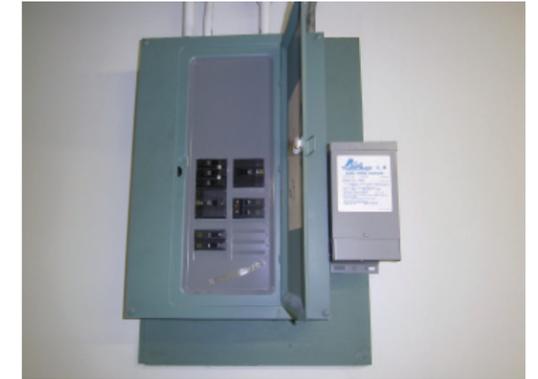
- Due to the age of the building, there are very few 120 / 240 V(ac) power receptacle outlets throughout the facility. It was noted that there are “power strips” in specific office areas. In addition, the Danville Parks & Recreation staff indicated that they have had (and continue to have) issues with fuses “blowing” on a regular basis. It is surmised that there may be specific pieces of equipment, tied to specific circuits, that are creating this problem. (Pictures 52, 53 and 54)

53: Electrical service

54: Electrical service

- With the electrical distribution system being in the worst condition, the upgrade to a 208/120 volt “wye” system with new switchgear and distribution panelboards is the first utility system that should be replaced.

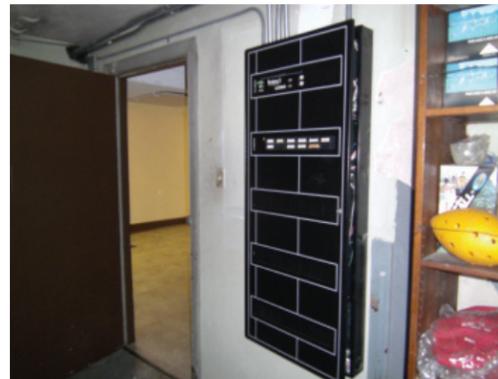
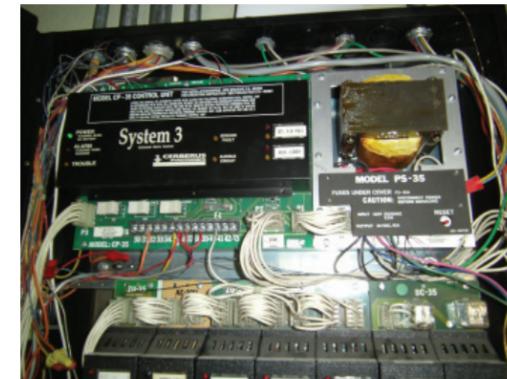
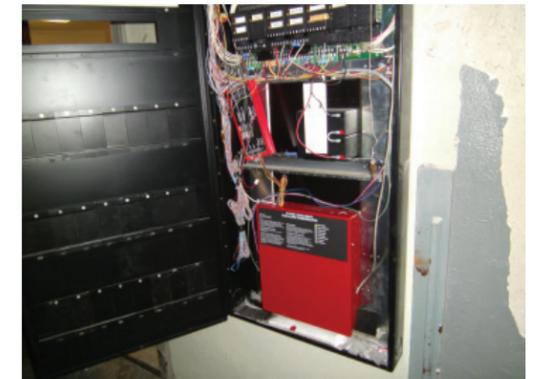
- The lighting system(s) appears to be in good condition and adequate for the tasks.
- The existing fire alarm control panel is in good condition, but does not have the capacity for expansion. The existing fire alarm system does not fully comply with NEC in terms of pull stations and notification appliance quantities and placement.

56: Fire alarm control panel

57: Fire alarm control panel

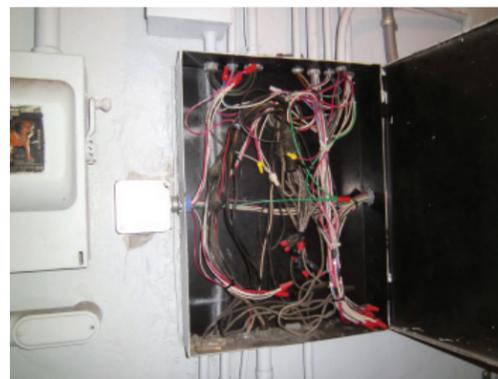
58: Fire alarm control panel

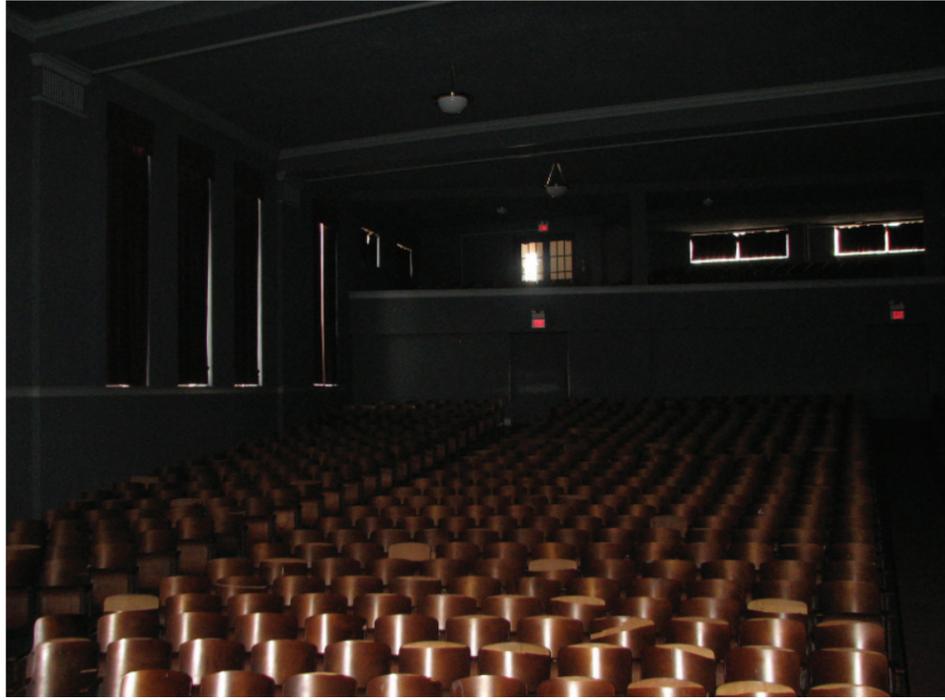
1: View from stage left to balcony

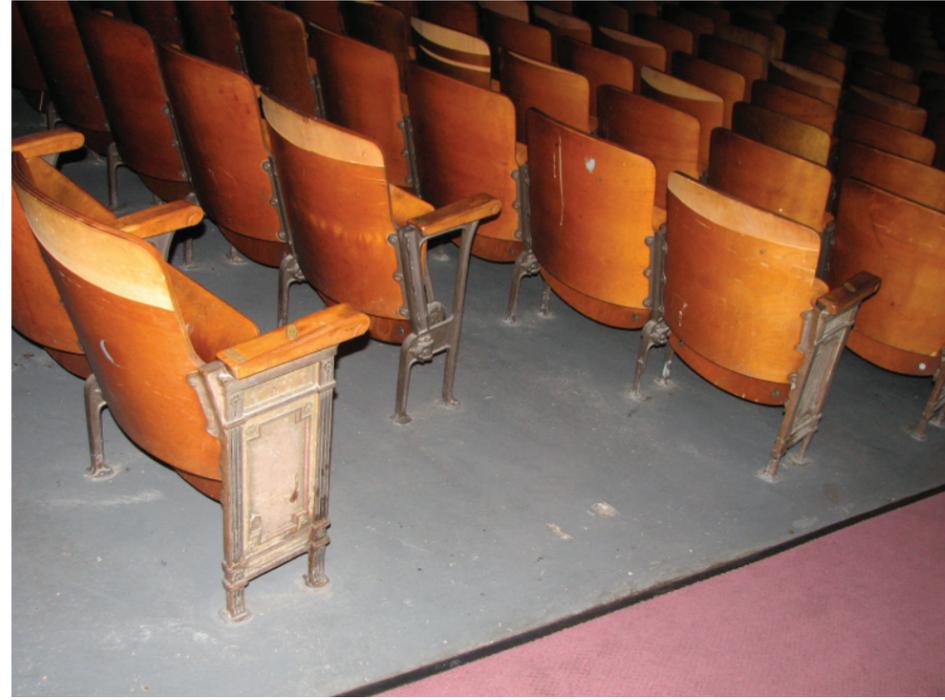
2: Original seats and end standards on sloped concrete floor

- It is possible to keep the existing, original seating in the balcony in its current format, unless there are sufficient funds to replace this seating. In its current configuration, the balcony seating can continue to be used for overflow seating.

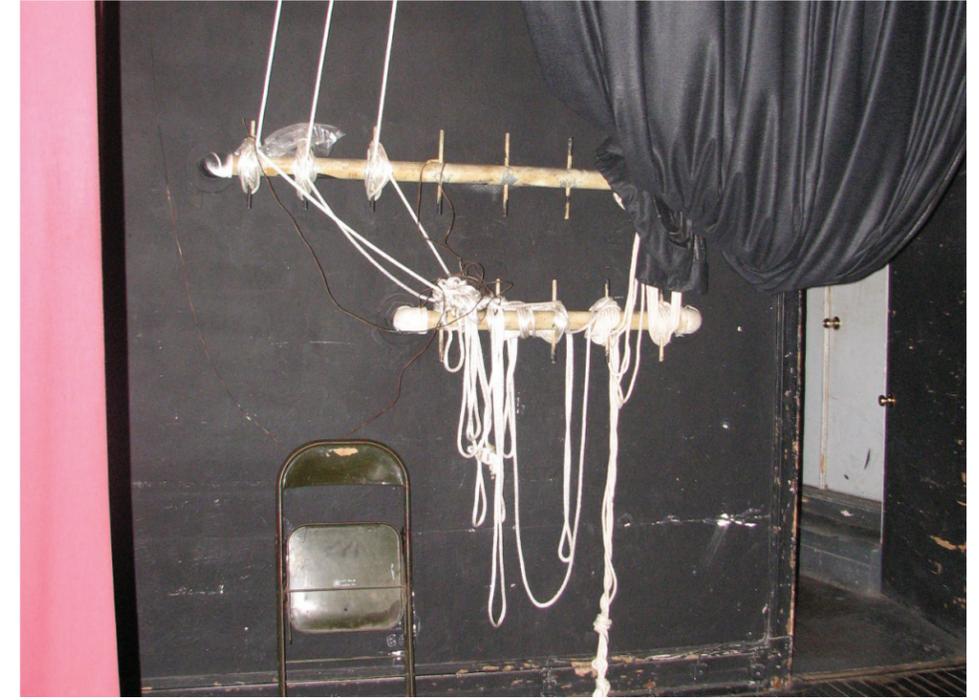
3: Rigging

- The side masking curtain pipes are dead-hung using non-rated chain.
- Electrical panel boxes are available on the “stage left” side of the stage. These boxes have been tapped-into over the years as evidenced by left-over and non-code-rated electrical distribution hardware elements that remain in place alongside the electrical disconnects. According to the electrical engineer who participated in the site review, all of this electrical equipment will have to be replaced.

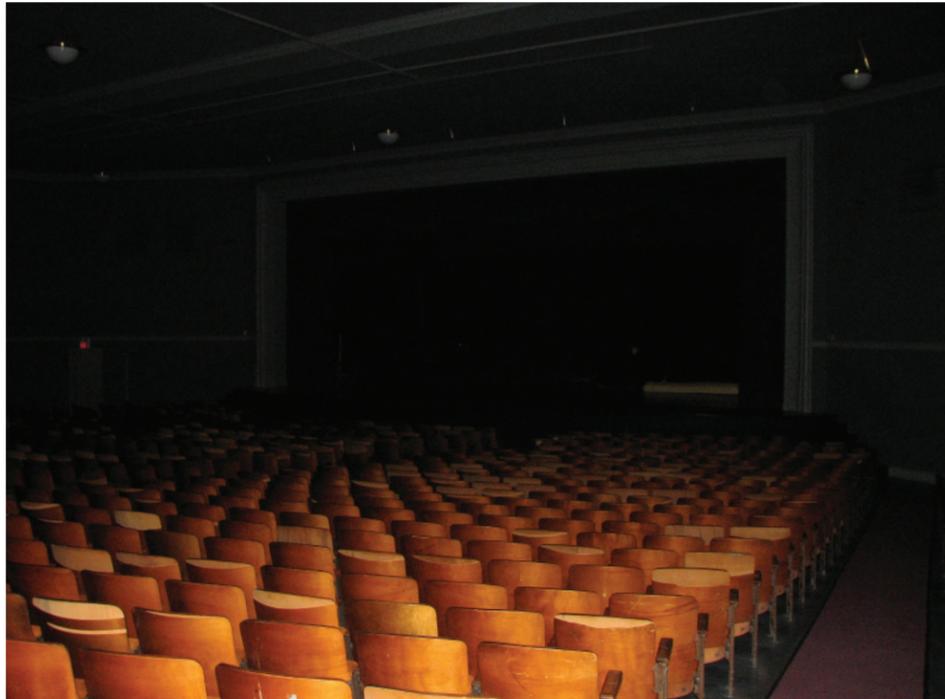
4: View from house right to stage
