RE: City Auditorium – Building Evaluation and Master Plan

CJMW Architecture is pleased to submit this building evaluation and master plan to the City of Danville.

Existing Conditions:

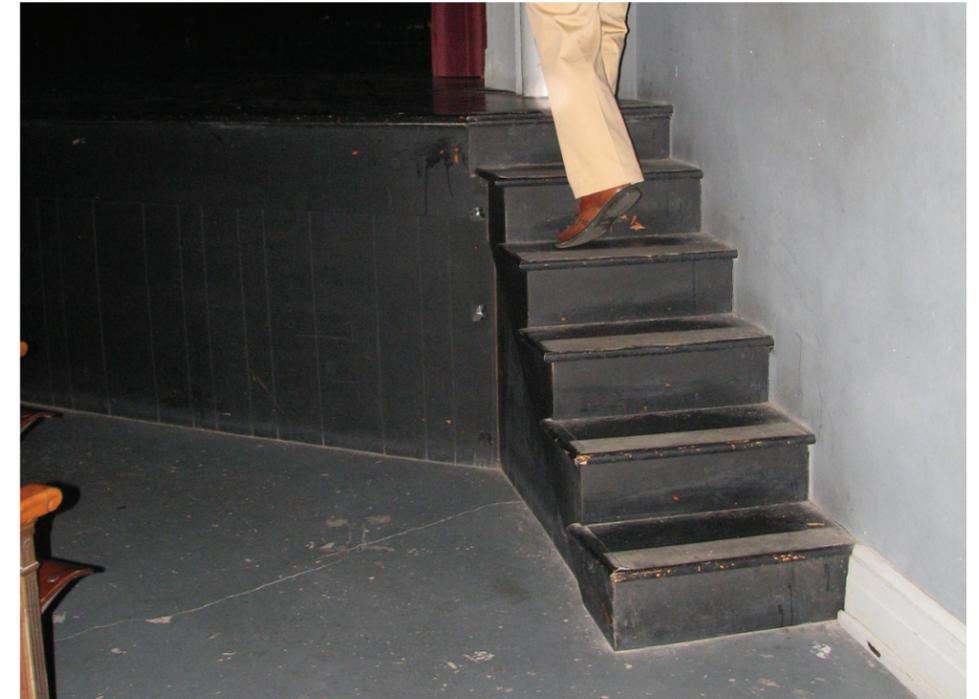
6: Stage access from orchestra seating level
